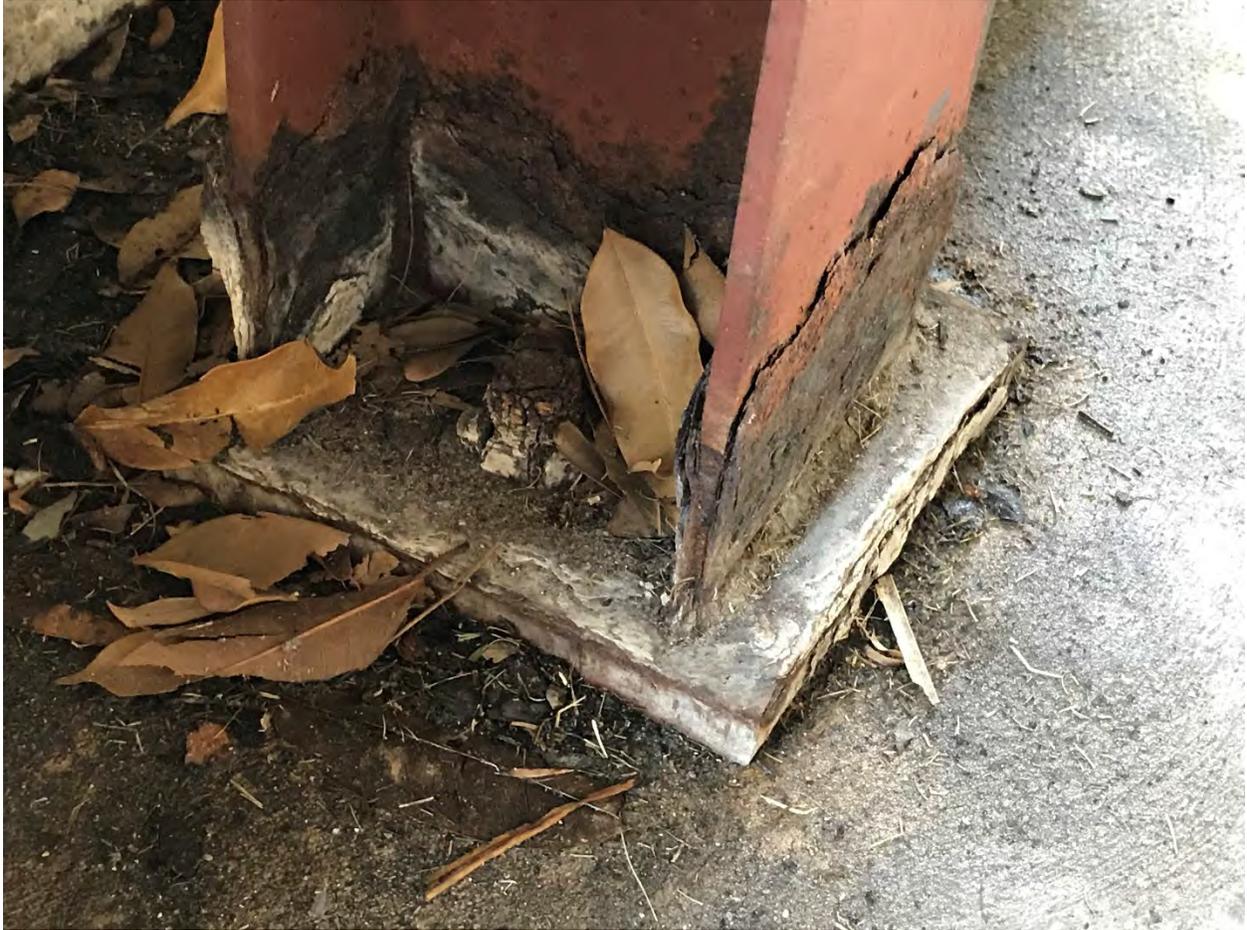
Photograph 88

Corrosion of rigid frame steel column base.

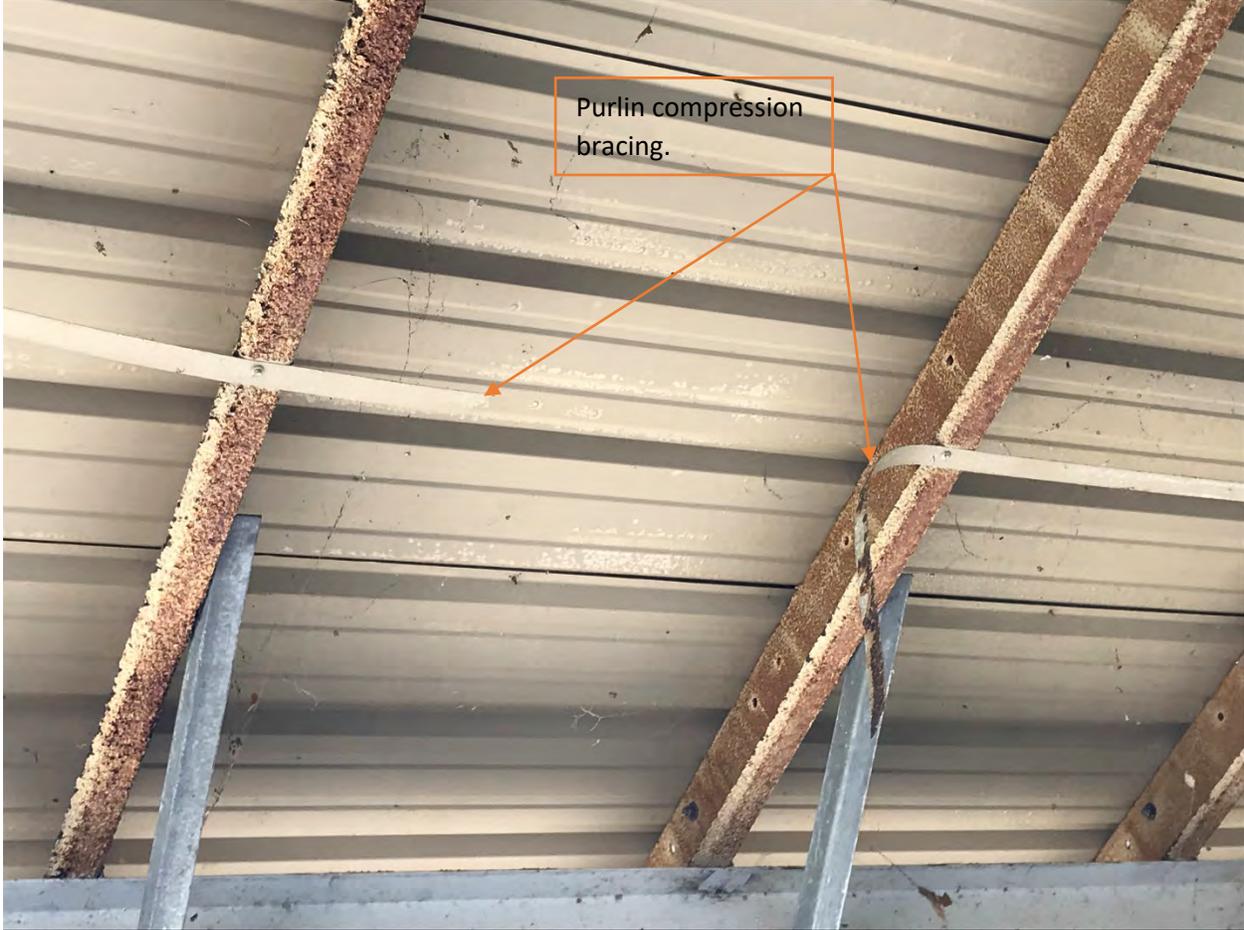
Photograph 89

Failed roof purlin compression bracing.

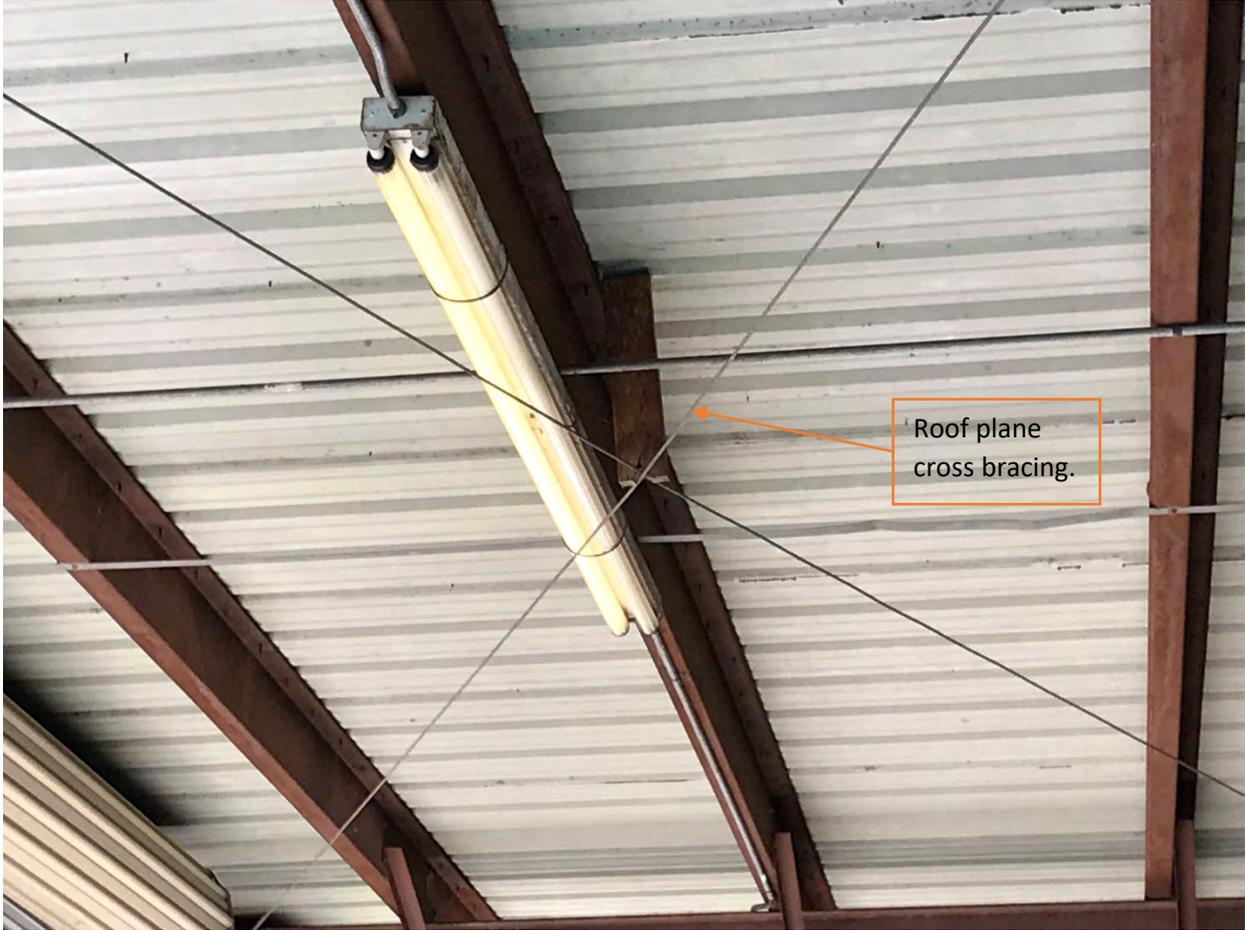
Photograph 90

Roof plane cross bracing, which transfers lateral load into building portal frames, is too loose.

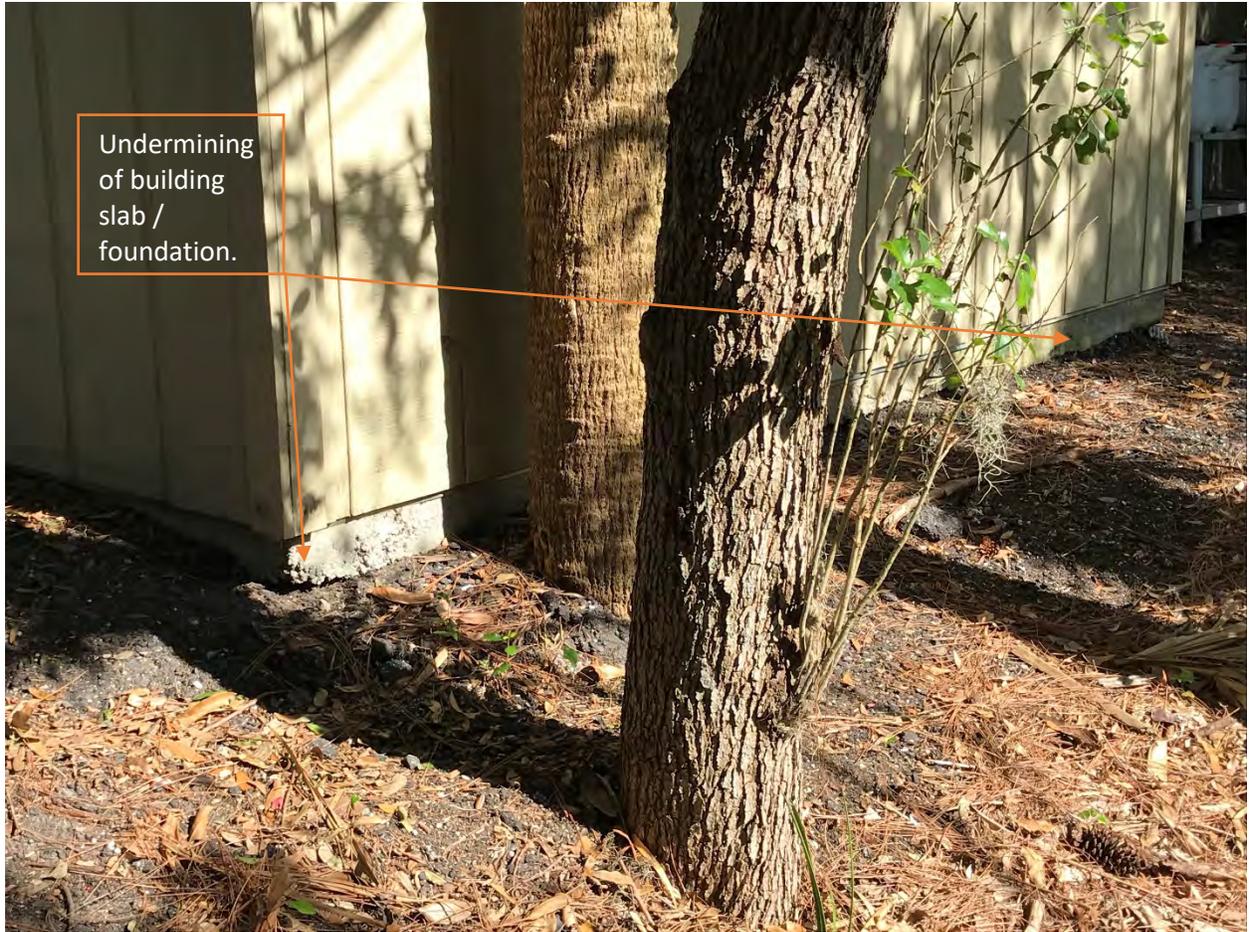
Photograph 92

Undermining
of building
slab /
foundation.

Undermining of building slab / foundation.

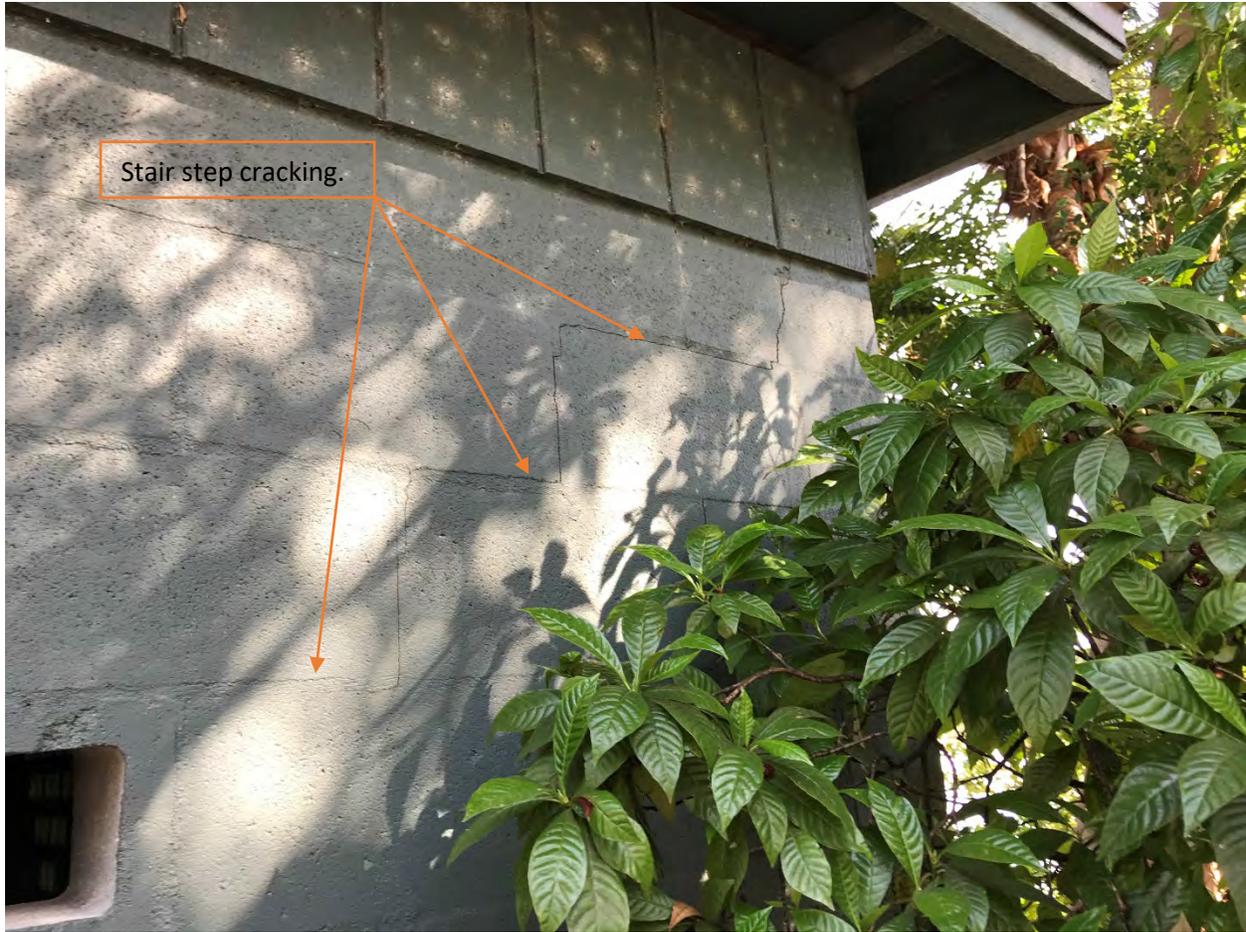
Photograph 94

Stair step cracking in exterior wall closest to pond. Cracking is evidence of settlement.

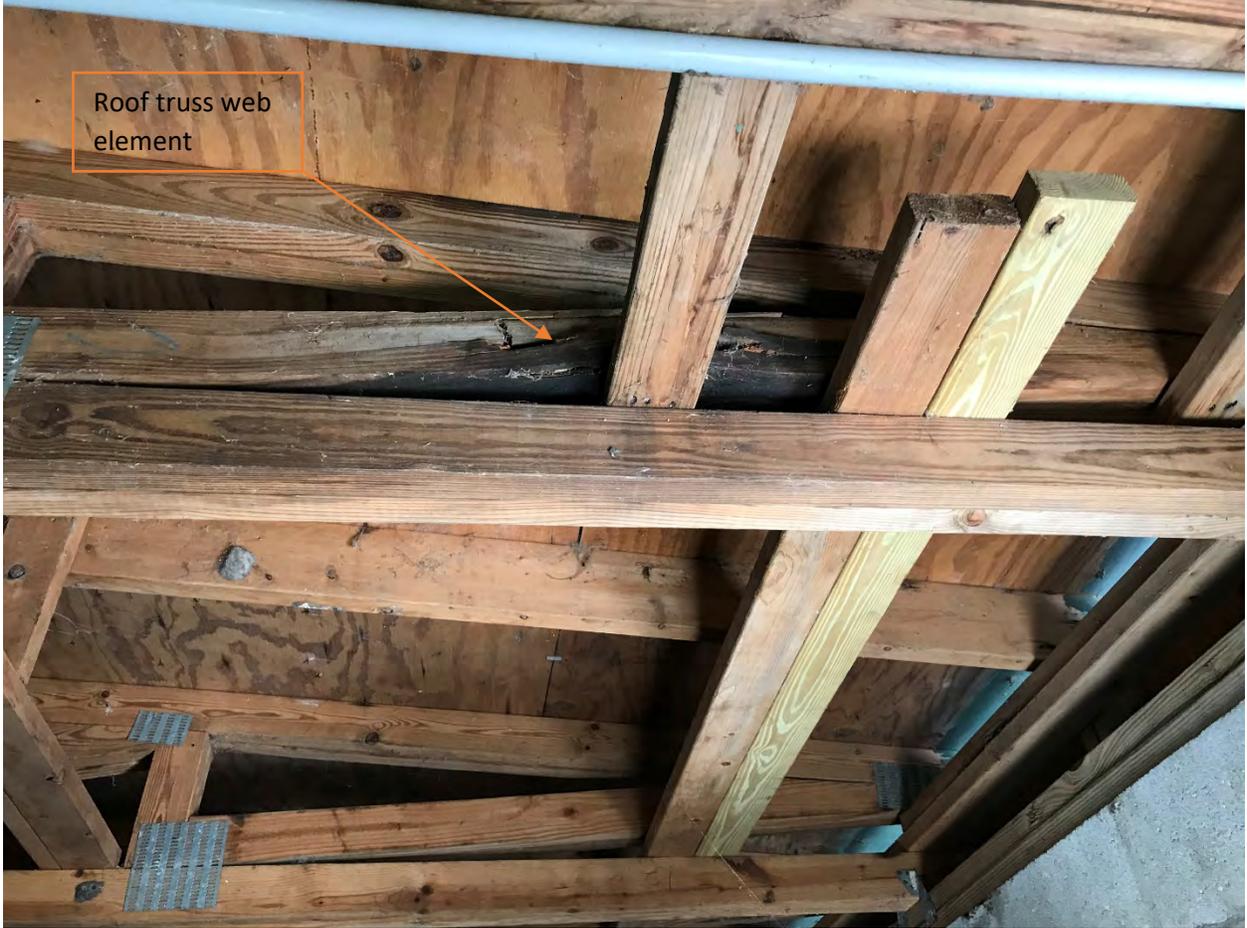
Photograph 95

Damage to roof truss web element caused by water damage.

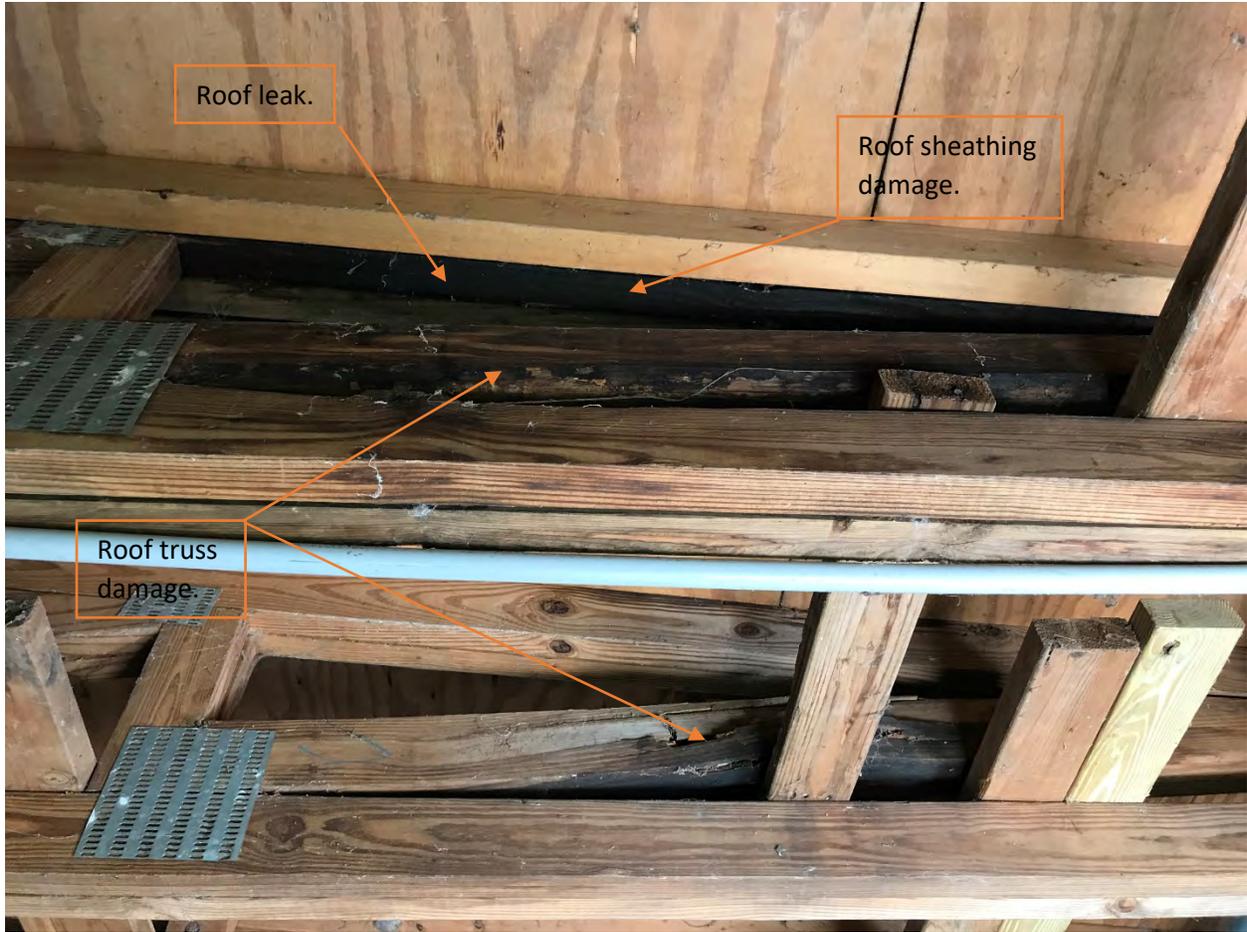
Photograph 96

Roof leak causing damage to roof sheathing and roof truss.

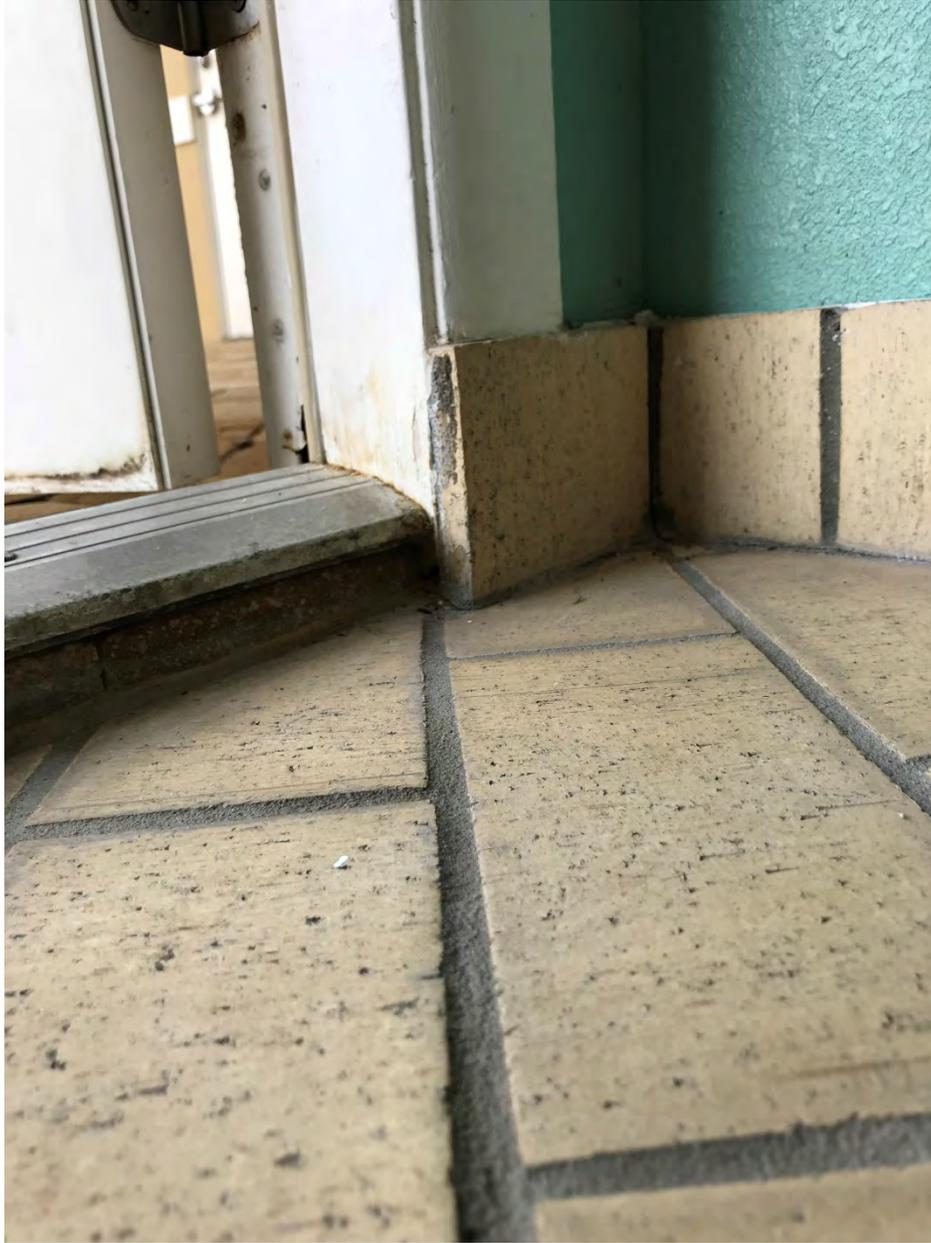
Photograph 98

Non-ADA compliant entry.

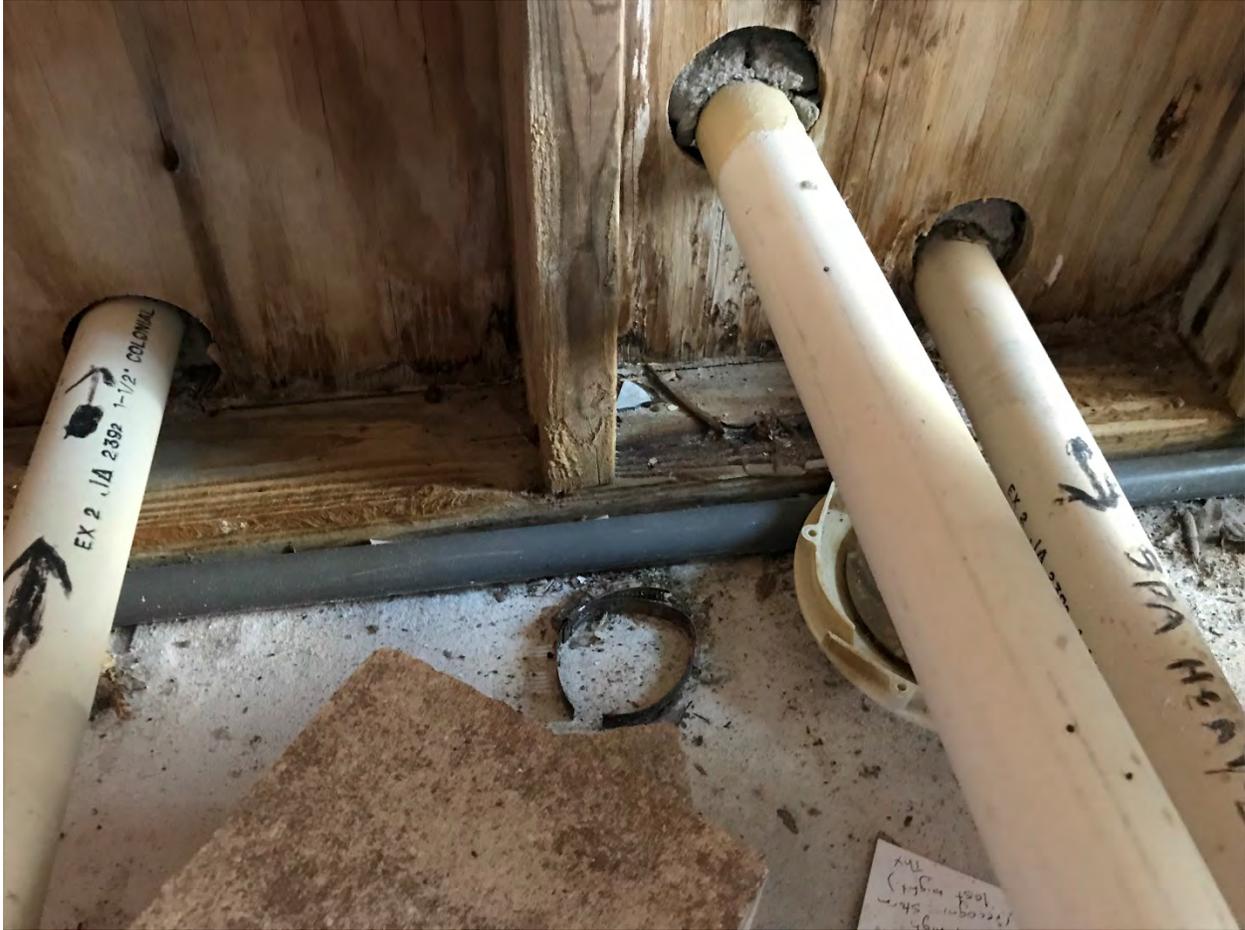
Photograph 99

Water damage to exterior wall framing. Water damage is assumed to be caused by exterior grade being higher than wall construction, rain and irrigation water intrusion through failed wall exterior finishes. Picture also indicates lack of stud tie down.

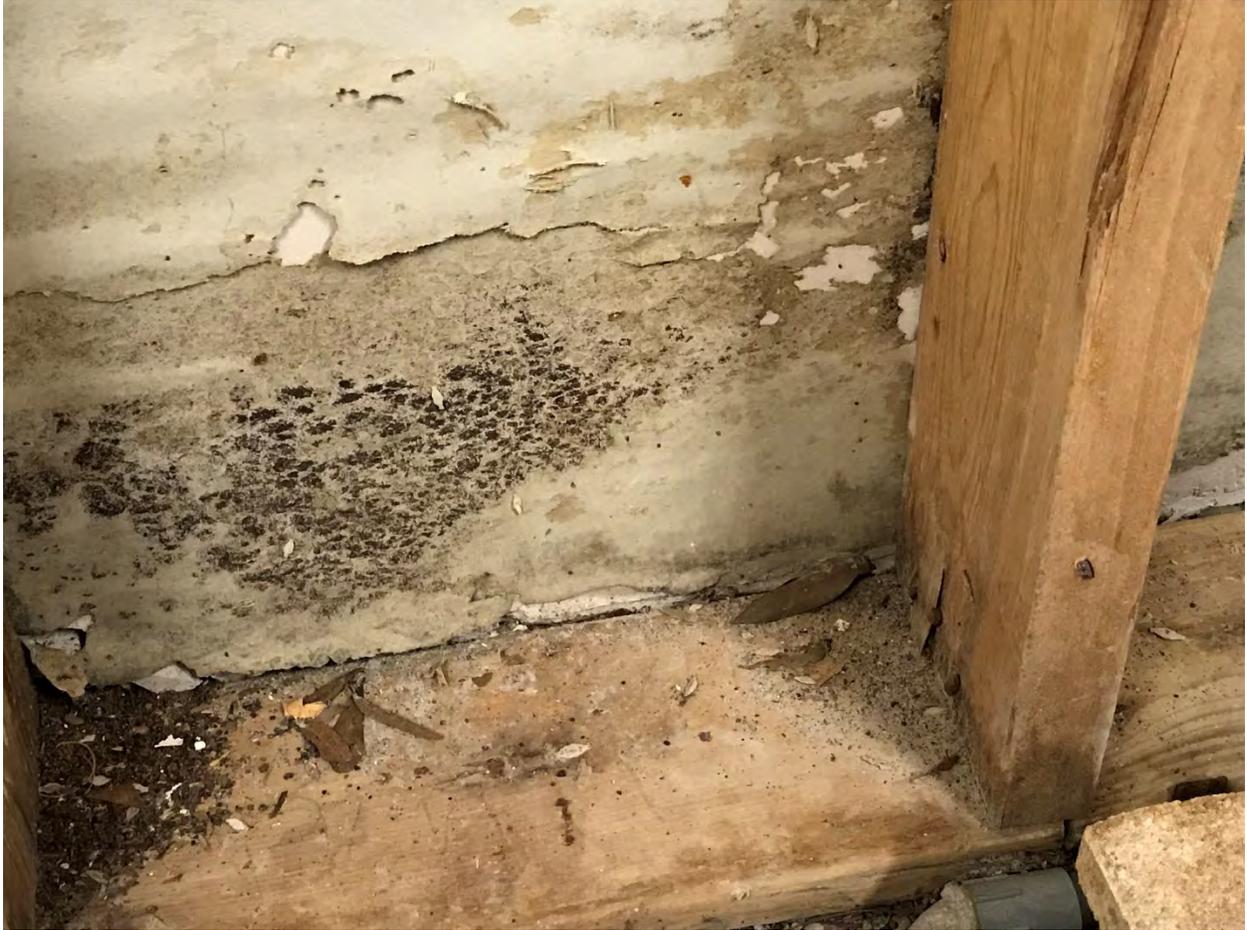
Photograph 100
Water damage to interior wall drywall. Black mold was present throughout.

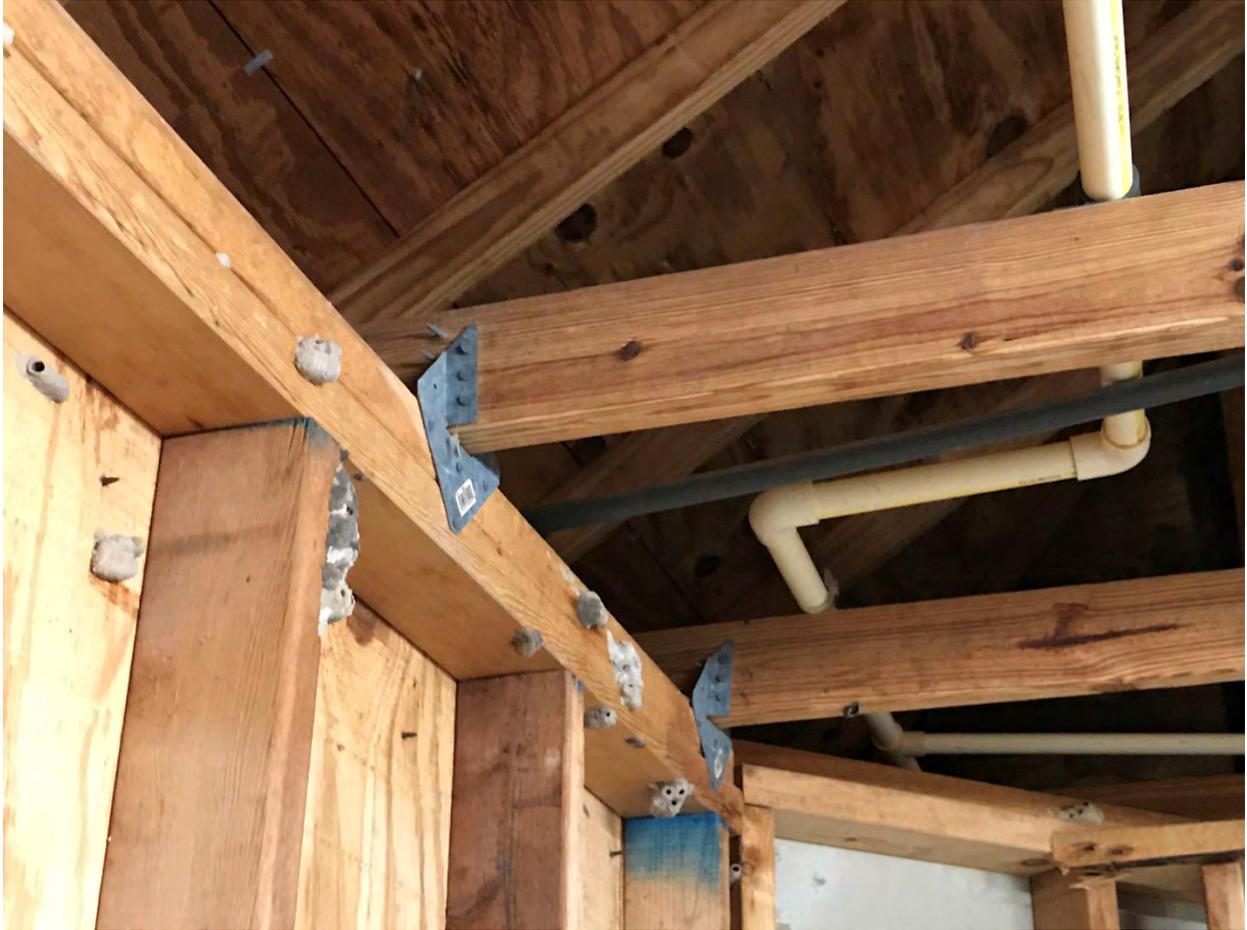
Photograph 101

Improper tie-down at truss to wall interface. Tie-down should provide restraint to top of wall but allow truss to deflect vertically.

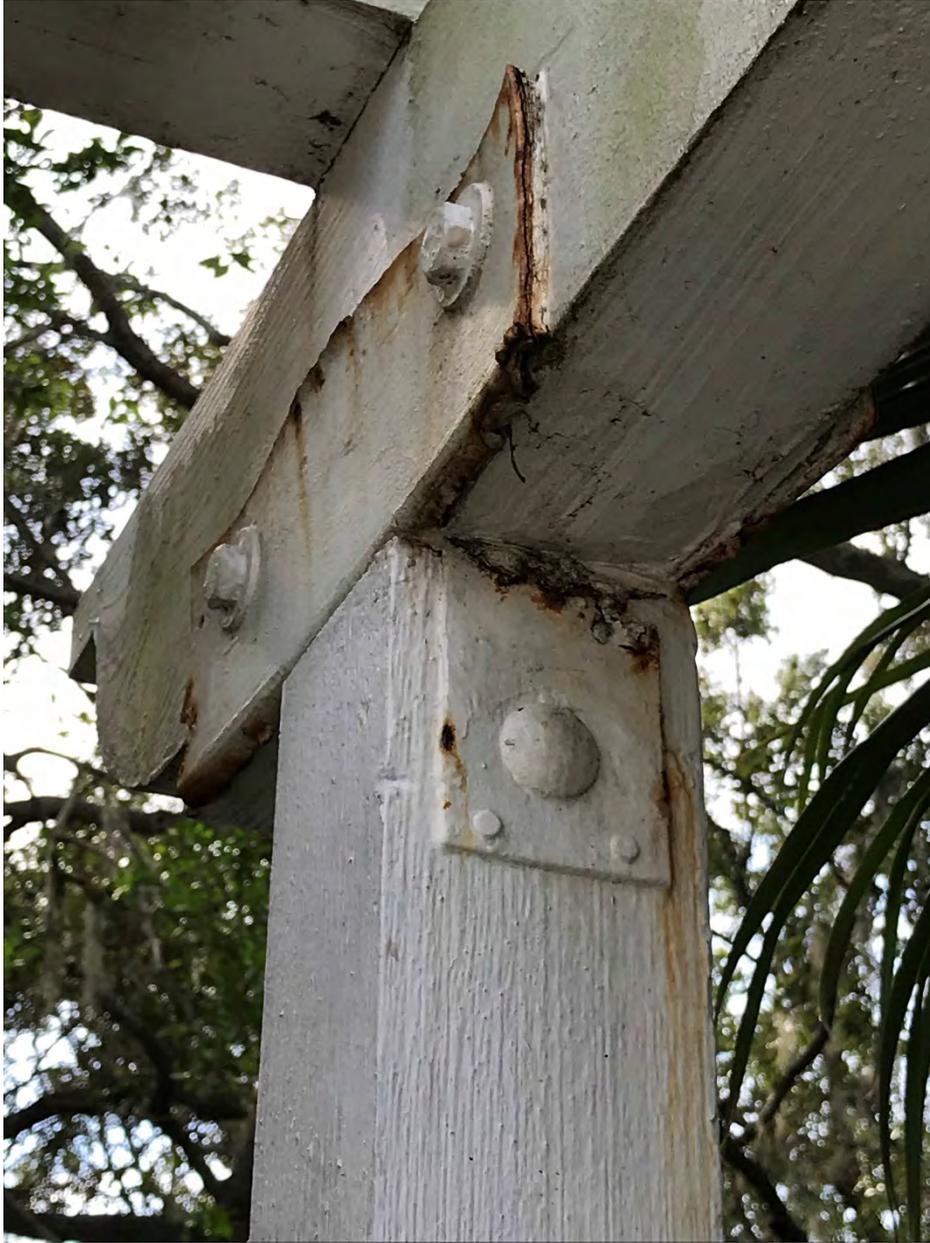
Photograph 102

Corrosion of trellis framing connectors.

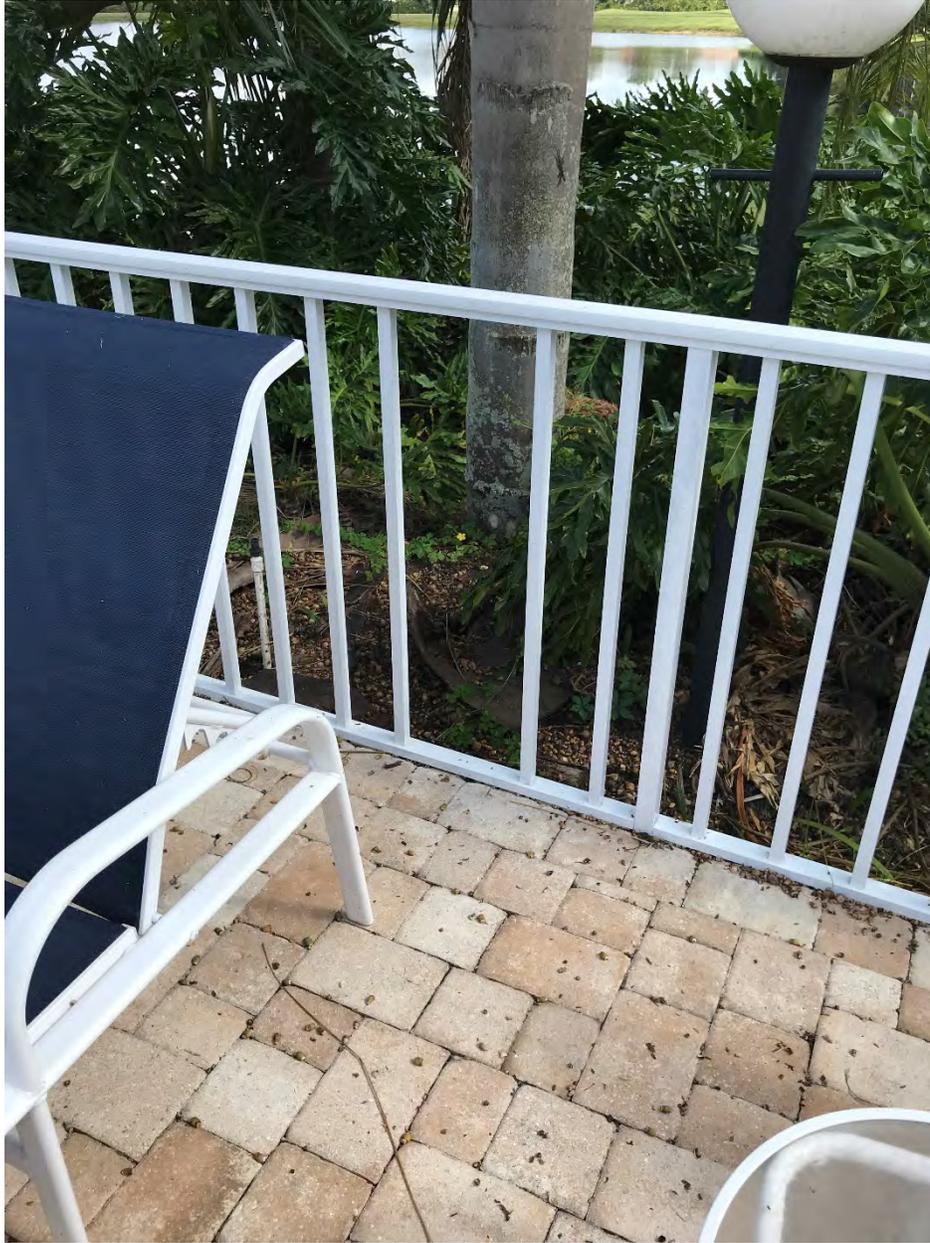
Photograph 103

Damage life-safety railing, (missing picket).

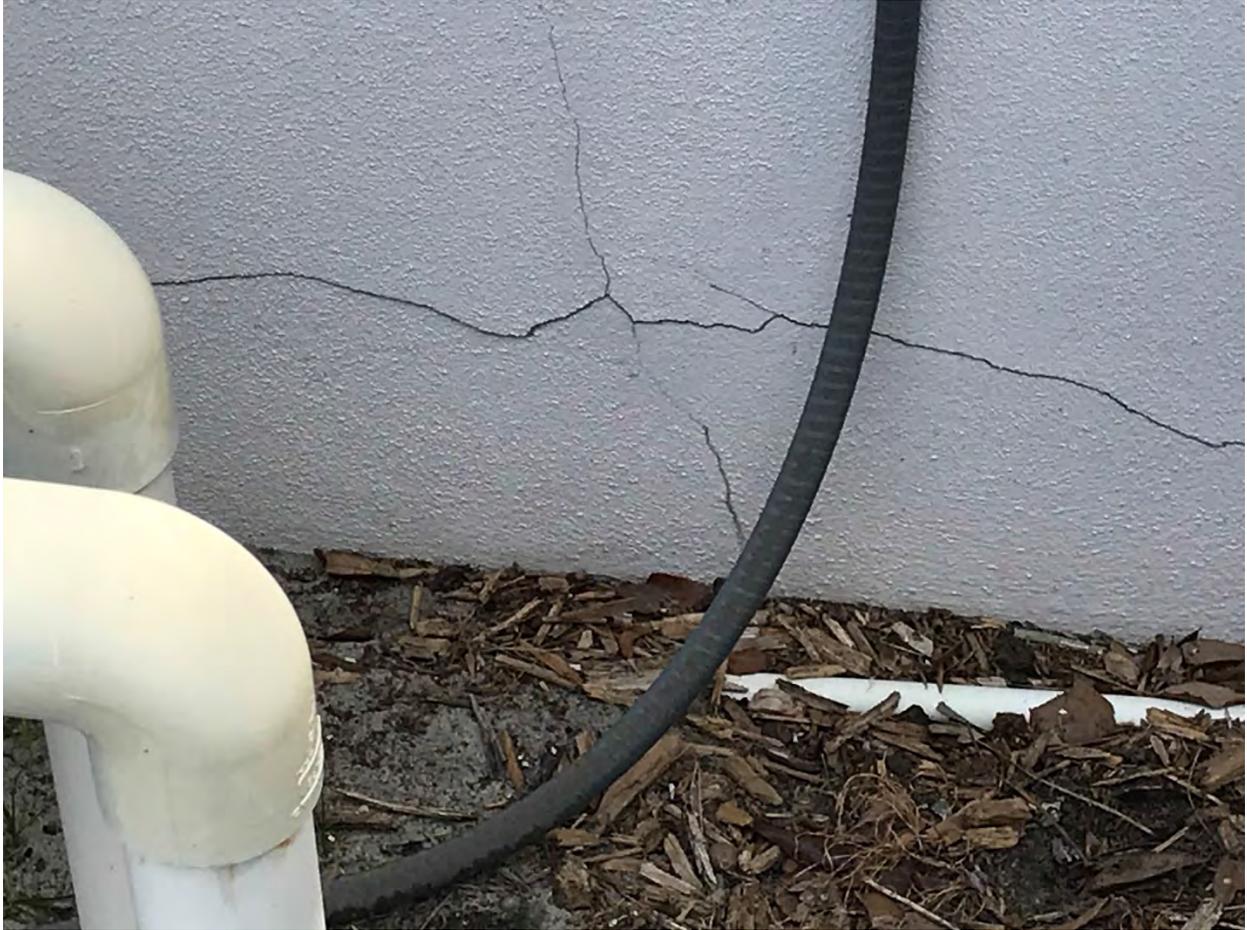
Photograph 104

Cracked and delaminated exterior wall stucco finish.

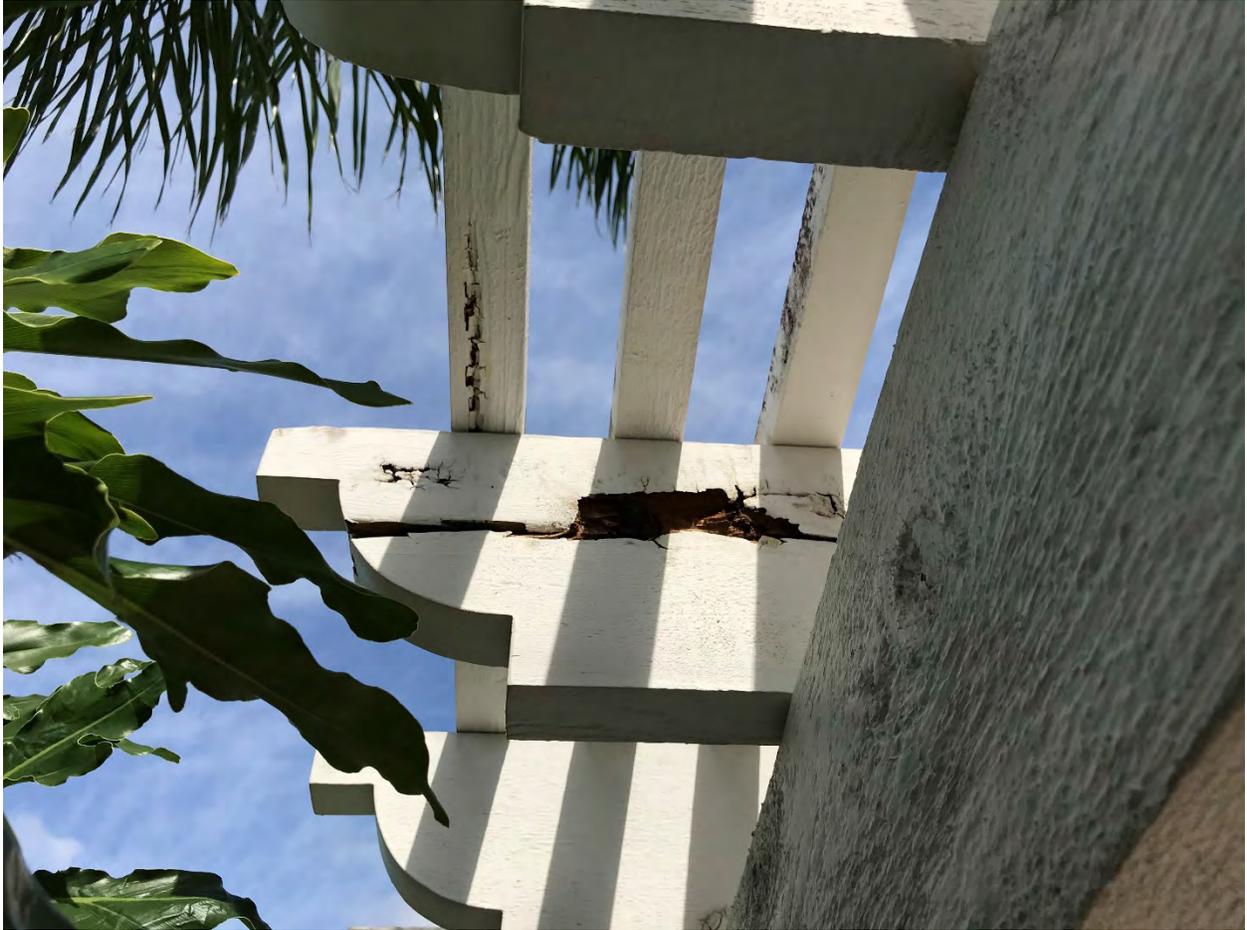
Photograph 106
Water damage to trellis framing members.

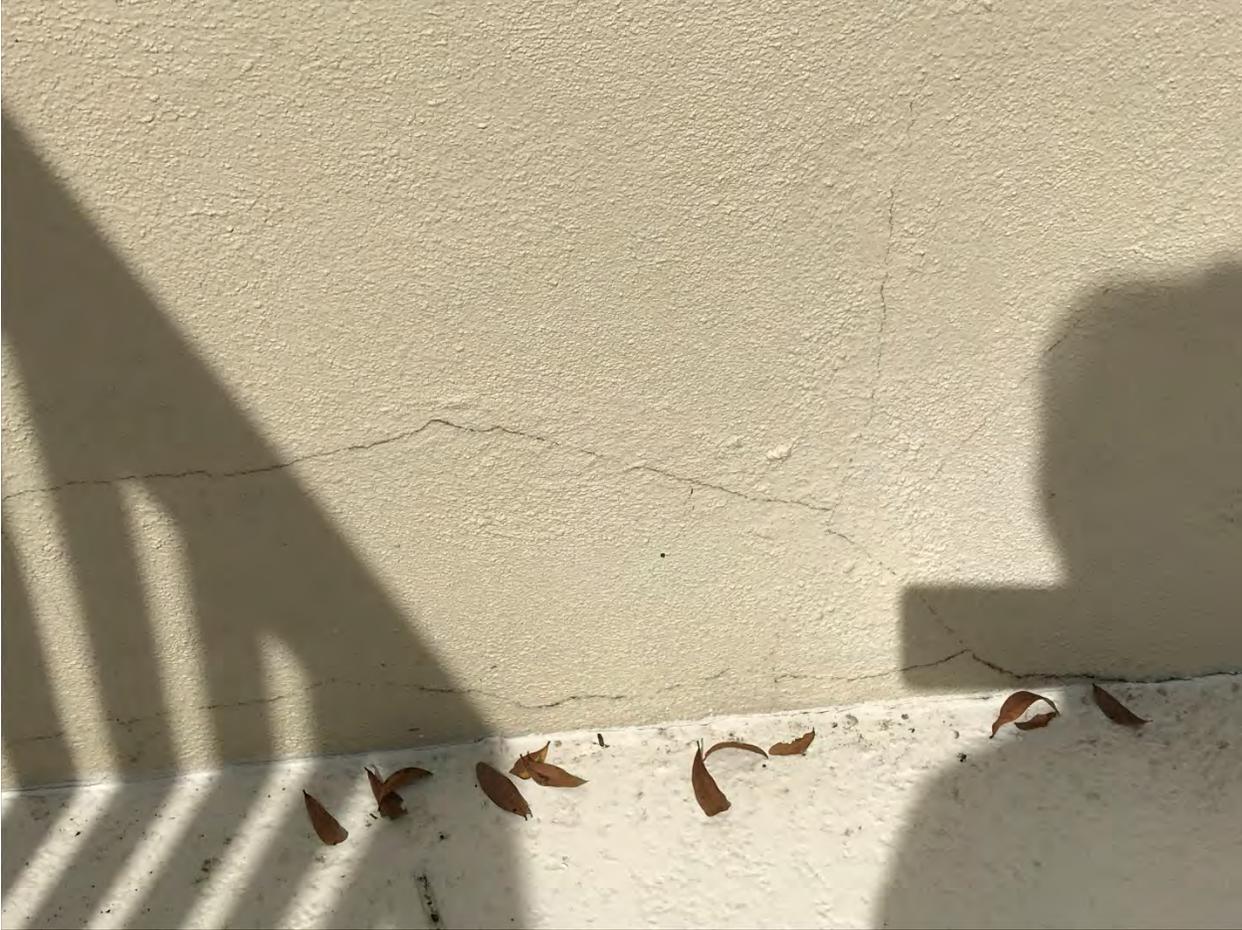
Photograph 107

Cracking of exterior wall stucco finish.

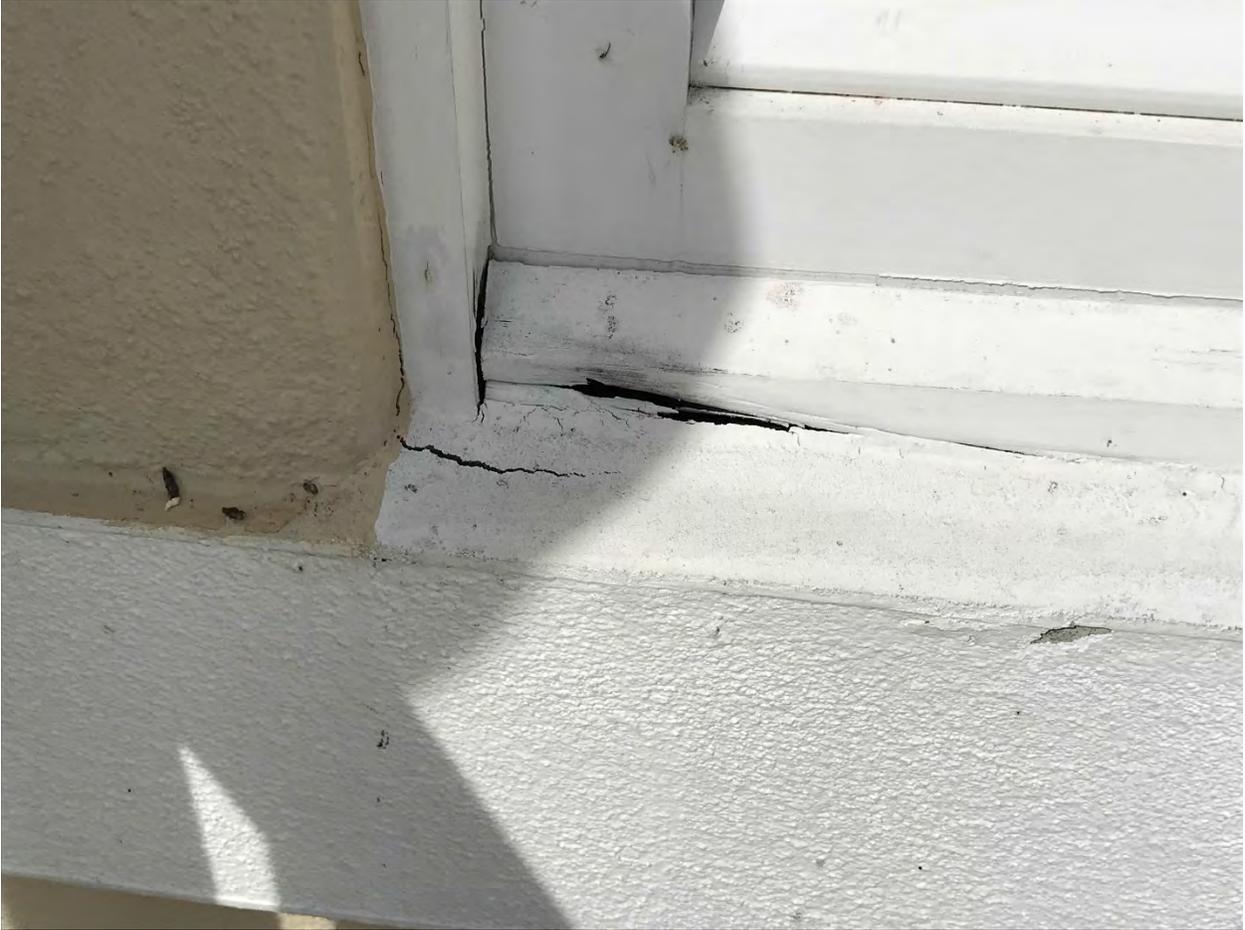
Photograph 108

Water damage to wall framing under window.

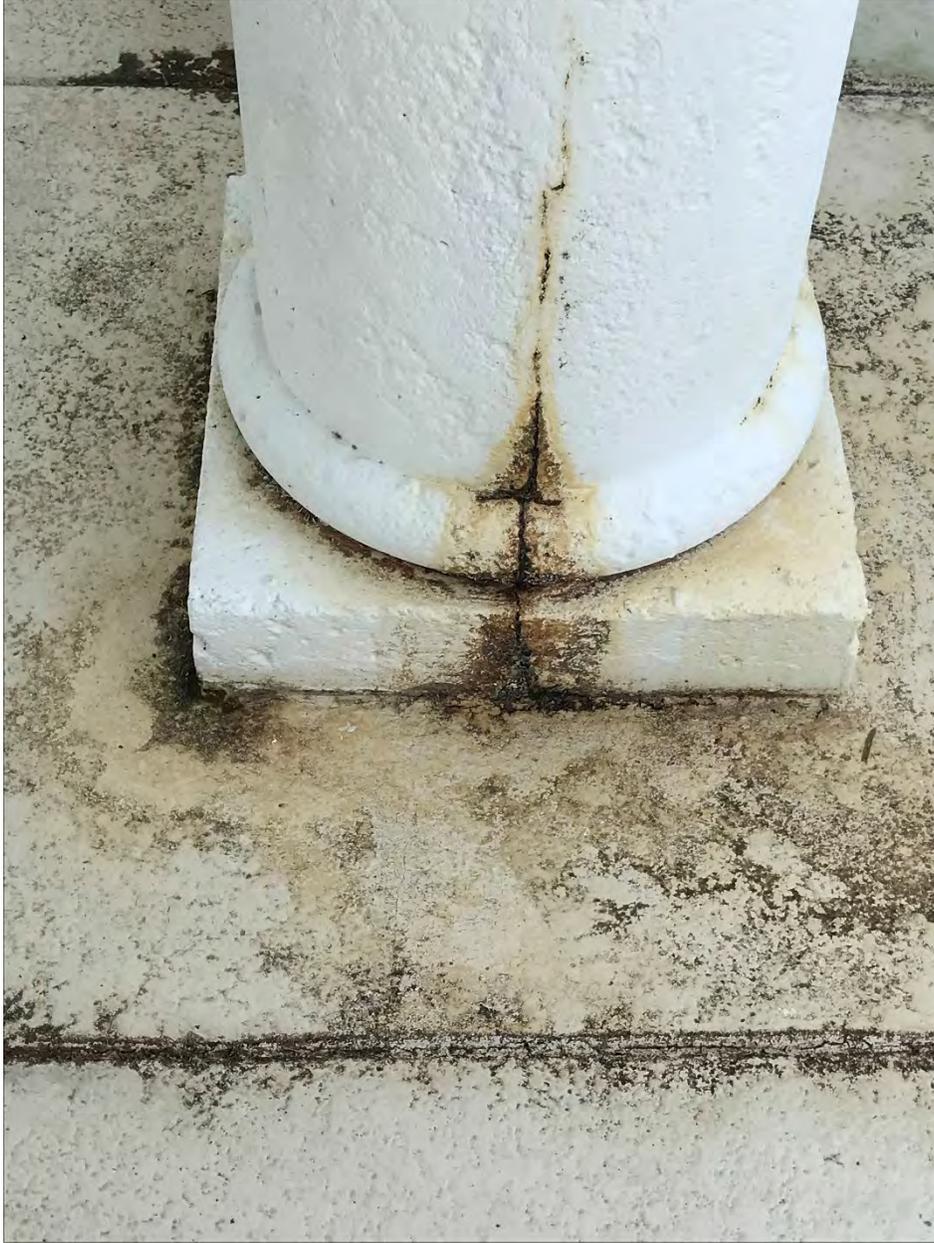
Photograph 110

Water evacuating base of precast concrete wrap. Evidence that water intrusion has occurred and possibly damaging structural column inside wrap.

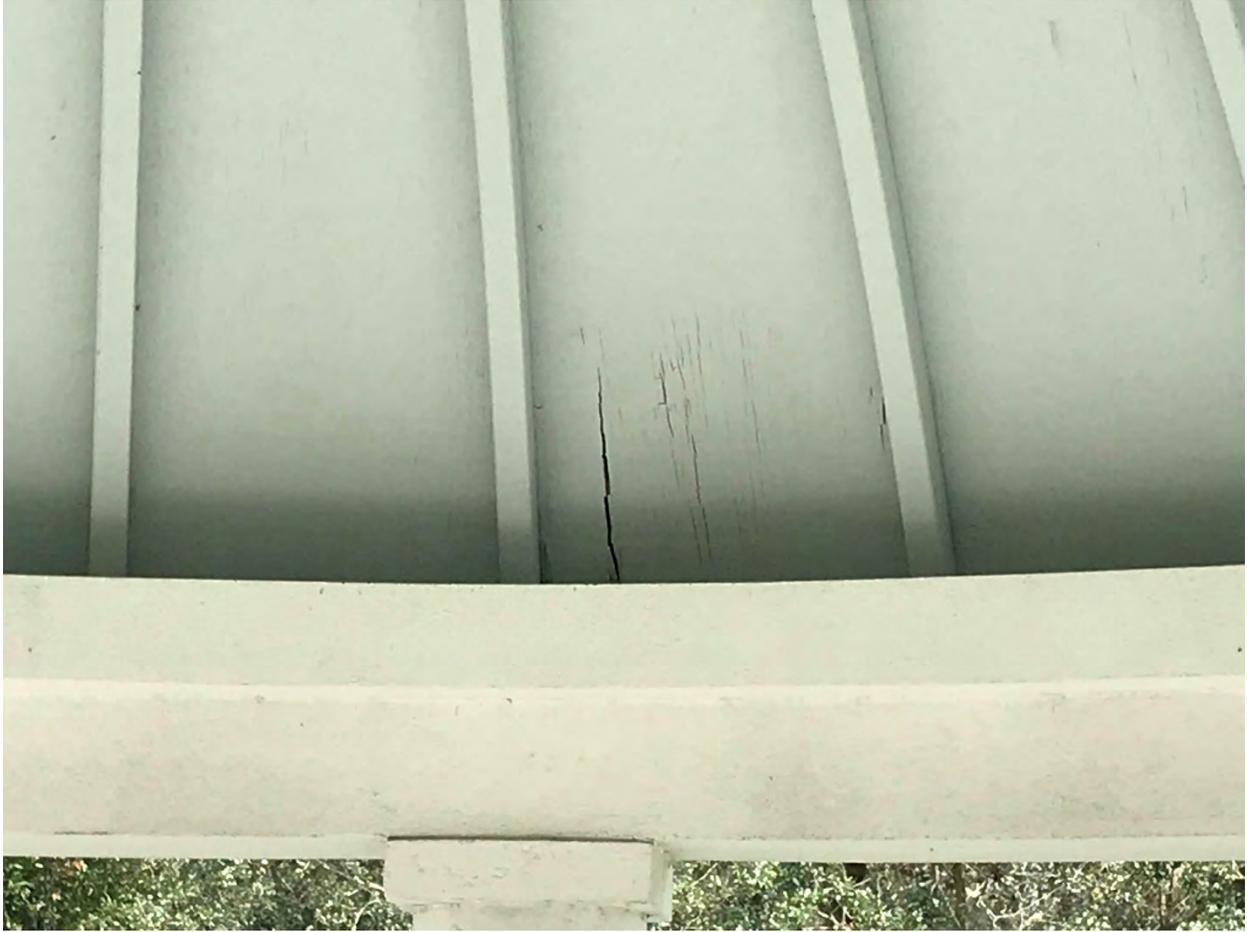
Photograph 111

Water damage to roof sheathing.
