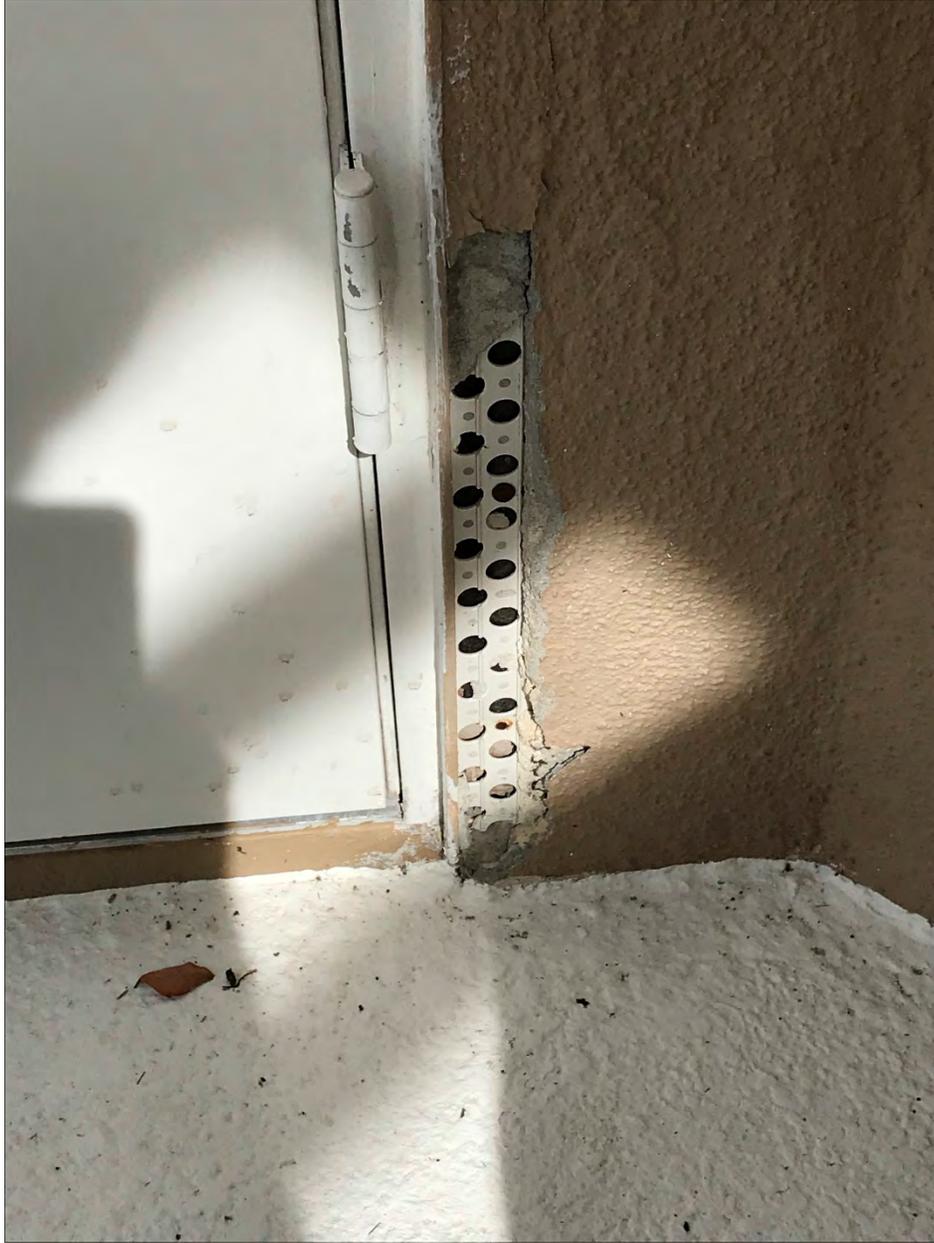
Photograph 113

Exterior wall stucco damage.

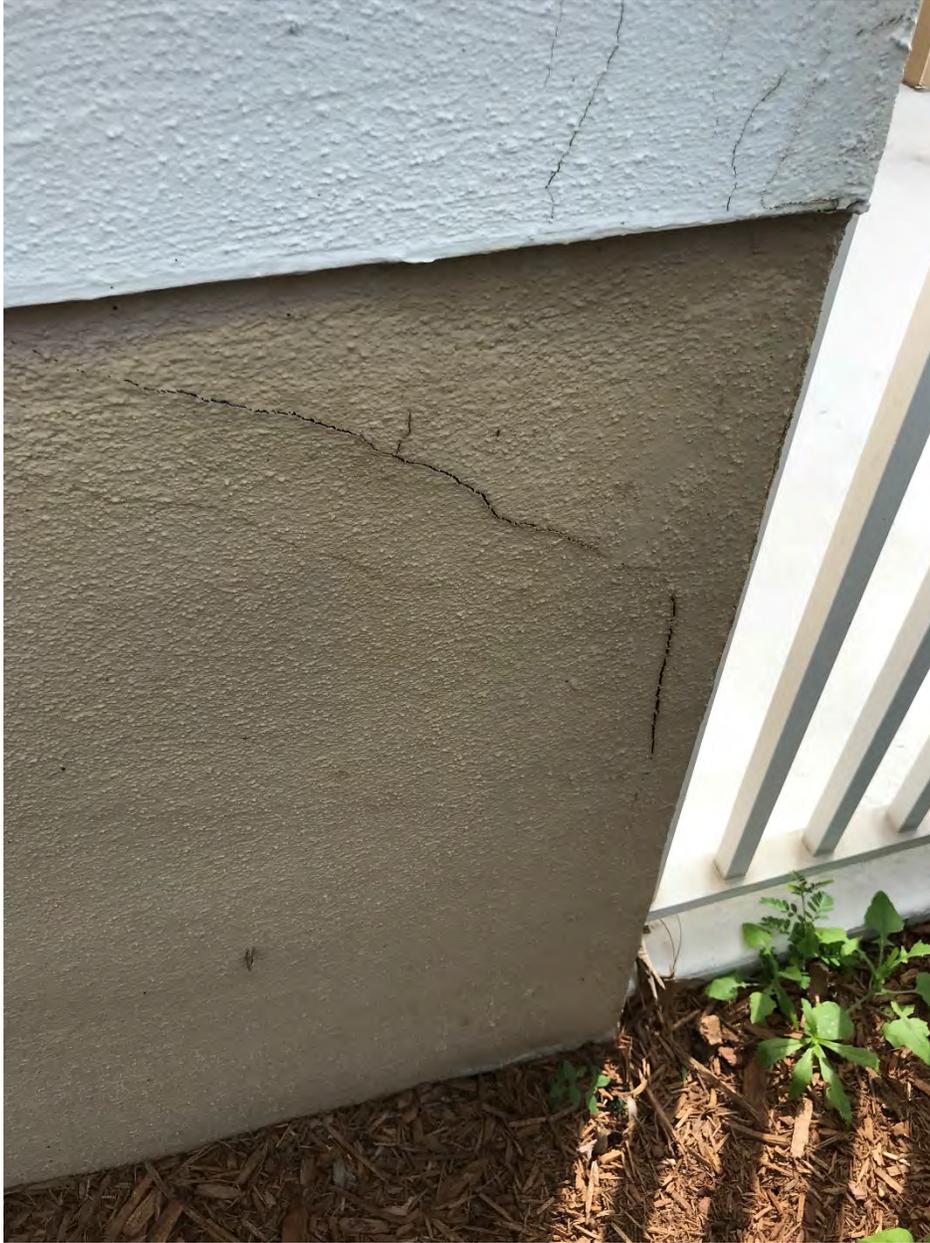
Photograph 114

Cracking and delamination of exterior wall stucco finish.

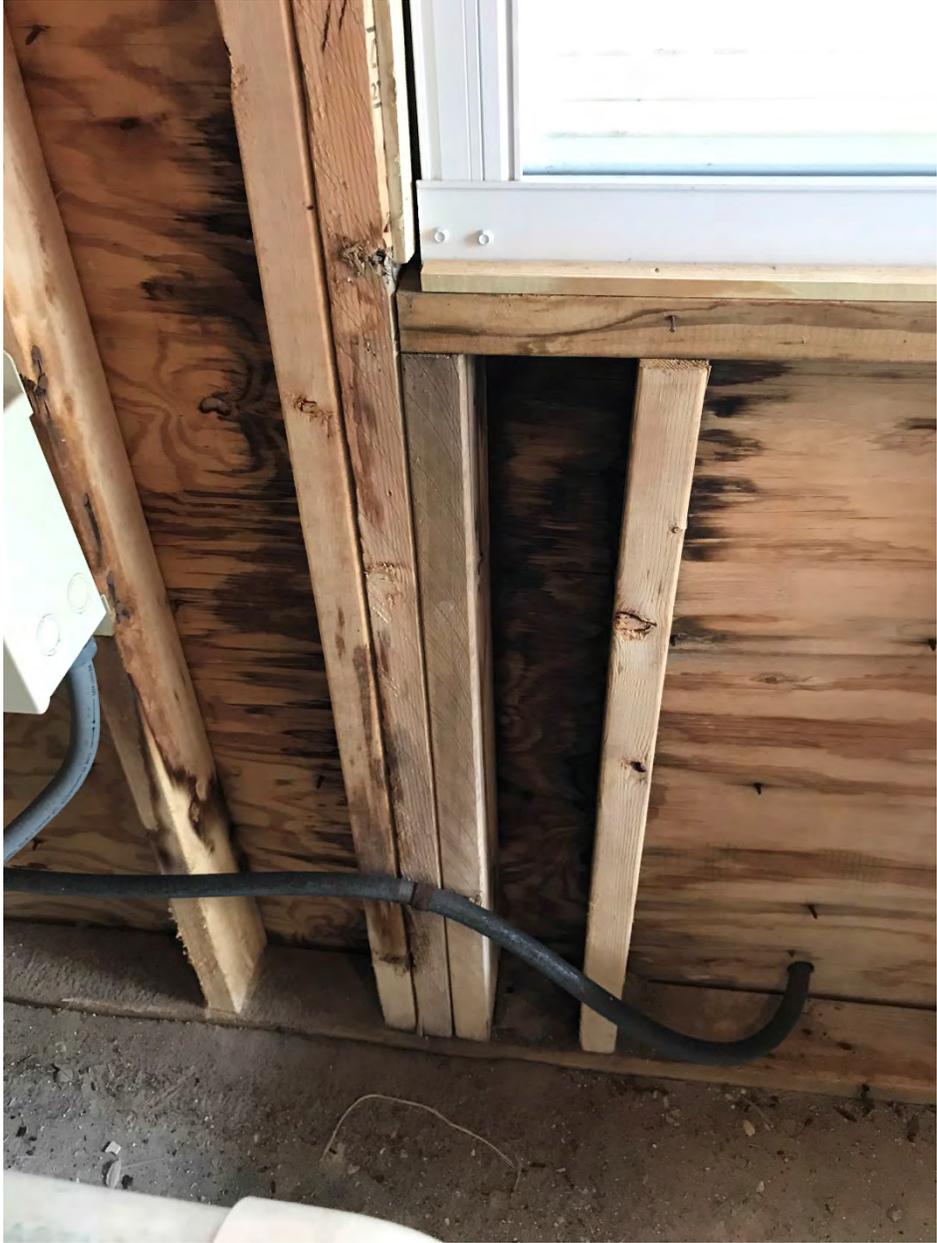
Photograph 115
Water damage to wall sheathing and framing.

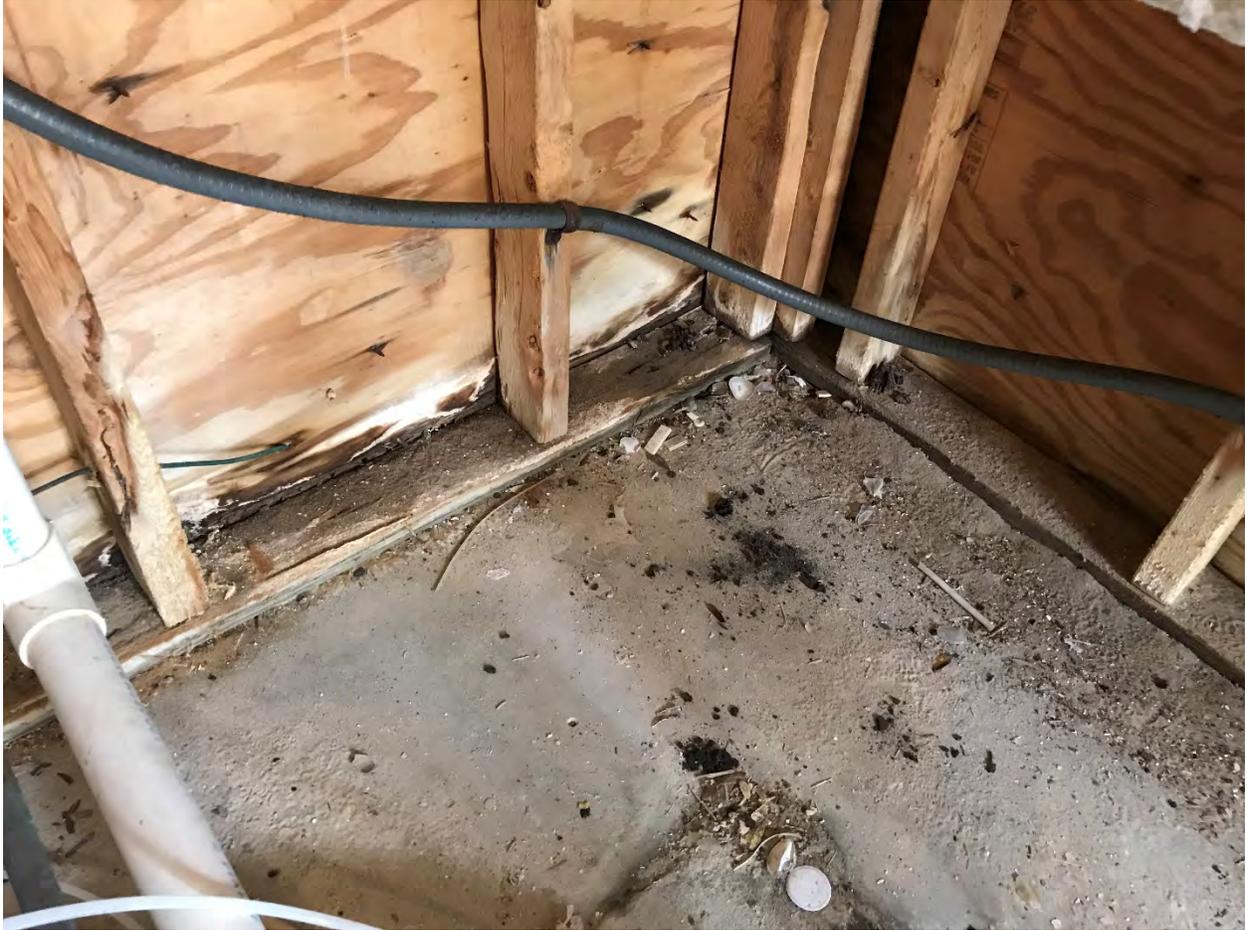
Photograph 116
Water damage to exterior wall sheathing and framing.
