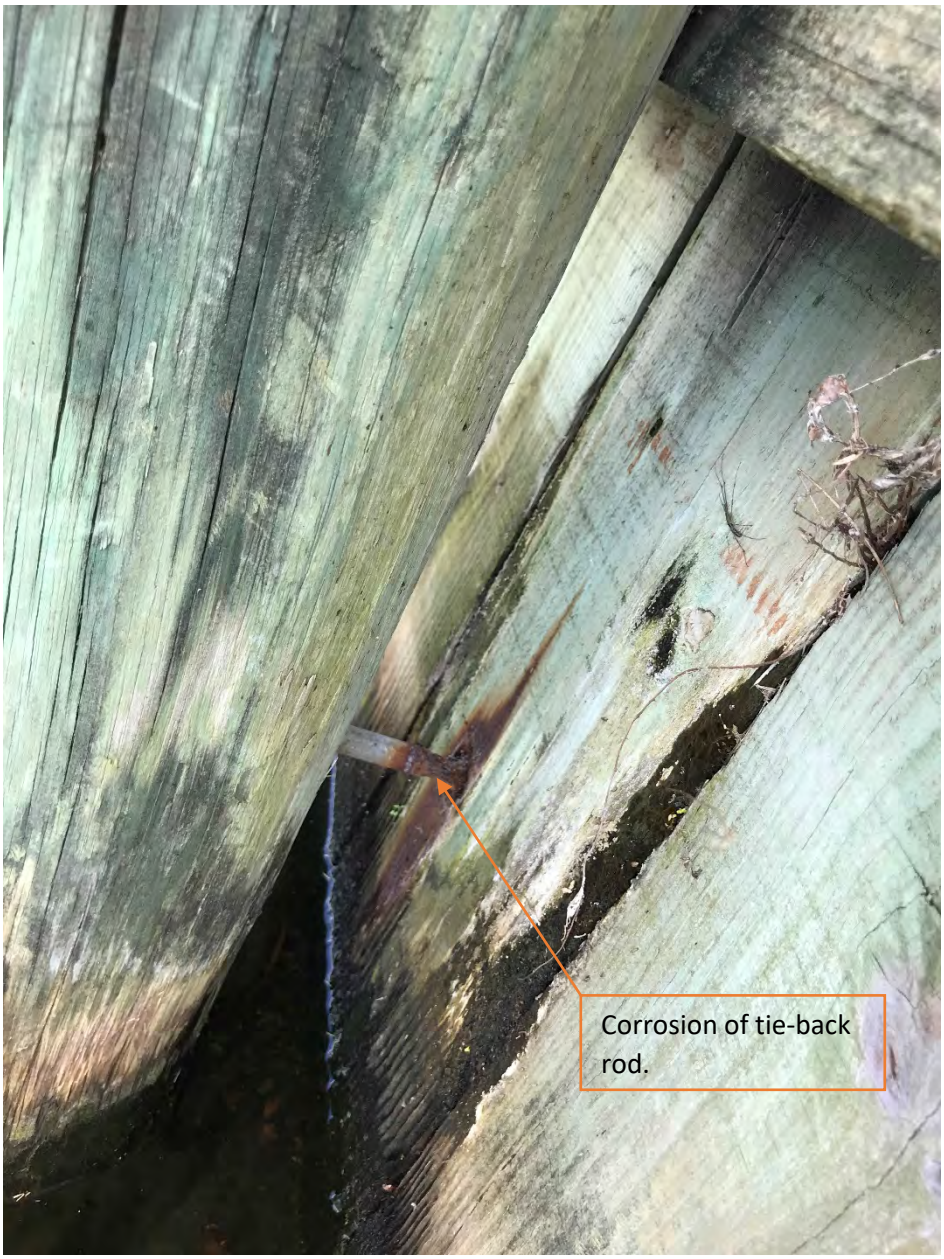
Photograph 119
Movement in retaining wall has caused the tie-back rod nut and washer to pull through the pile. Washers should have been thicker and larger in diameter.
